CLEANCOAT

CleanCoat Treatment of Cold Storage of Flowers

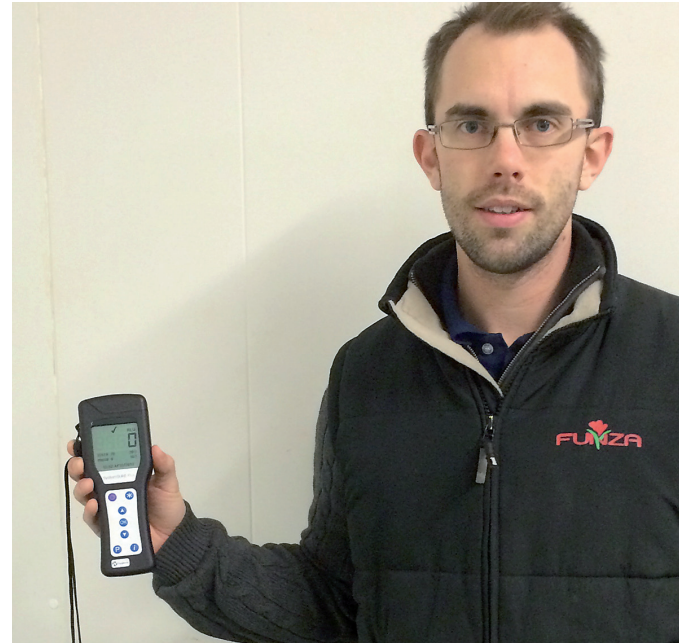
Cold Room, Temperature 3°C:

ATP units before treatment	ATP units after 30 sec.	ATP units after 1 hour	ATP units after 4 months
2689	610	0	10

Cold Room, Temperature 12°C:

ATP units before treatment	ATP units after 30 sec.	ATP units after 1 hour	ATP units after 8 months
3264	500	52	31

- 2689 ATP units before treatment in a cold room with 3 degrees C, after only 1 hour the value was 0.
- 3264 ATP units before treatment in a cold room with 12 degrees C, after only 1 hour the value was 52.
